HISTORIC STRUCTURE REPORT
Administrative, Historical and Architectural Data Sections
Seawall

FORT MCHENRY NATIONAL MONUMENT AND HISTORIC SHRINE
Maryland

Prepared by
Sharon A. Brown
and
Susan Long

August 1986

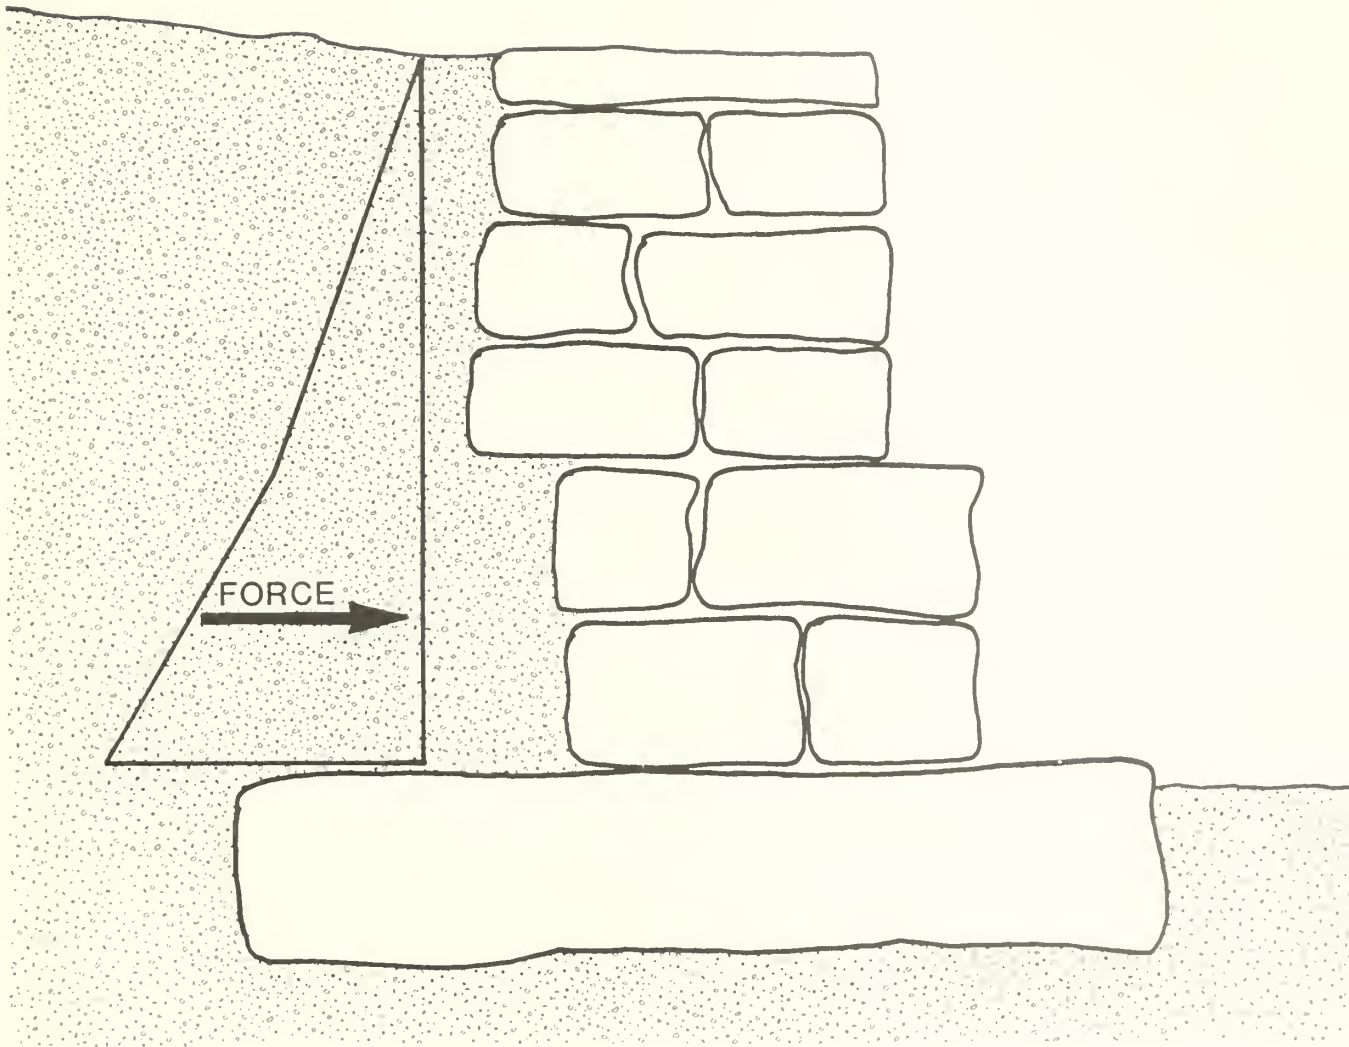
Figure 4: Lower third of wall displaced due to force created by water and plastic soil behind wall

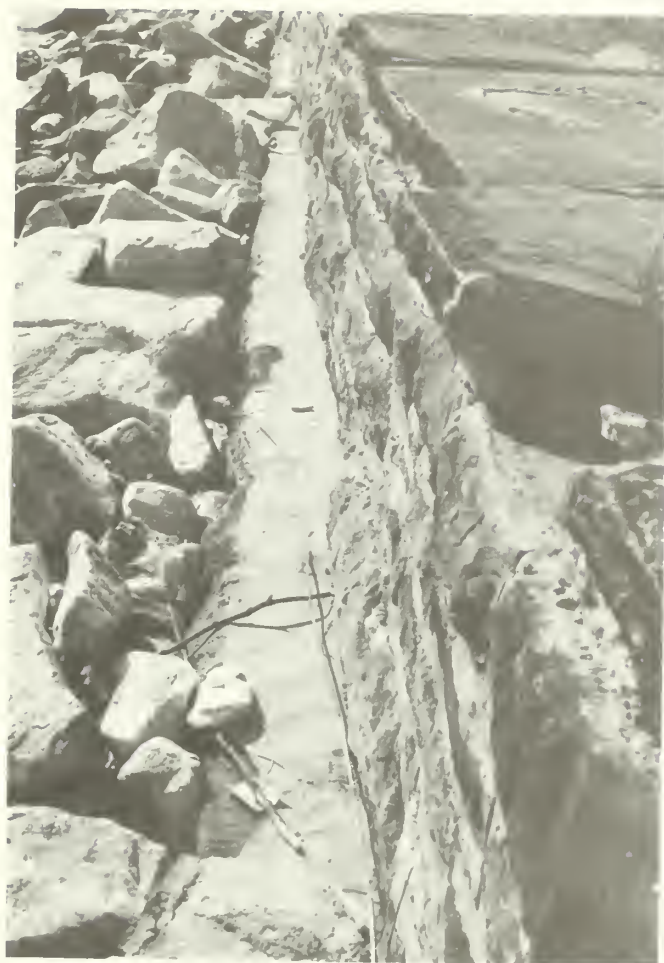
Photograph 5: Station 18 + 00. Protruding lower third of wall
